1. F/V "Prim Lady", Green Harbor
Marine, Brant Rock, MA on
November 23, 2004

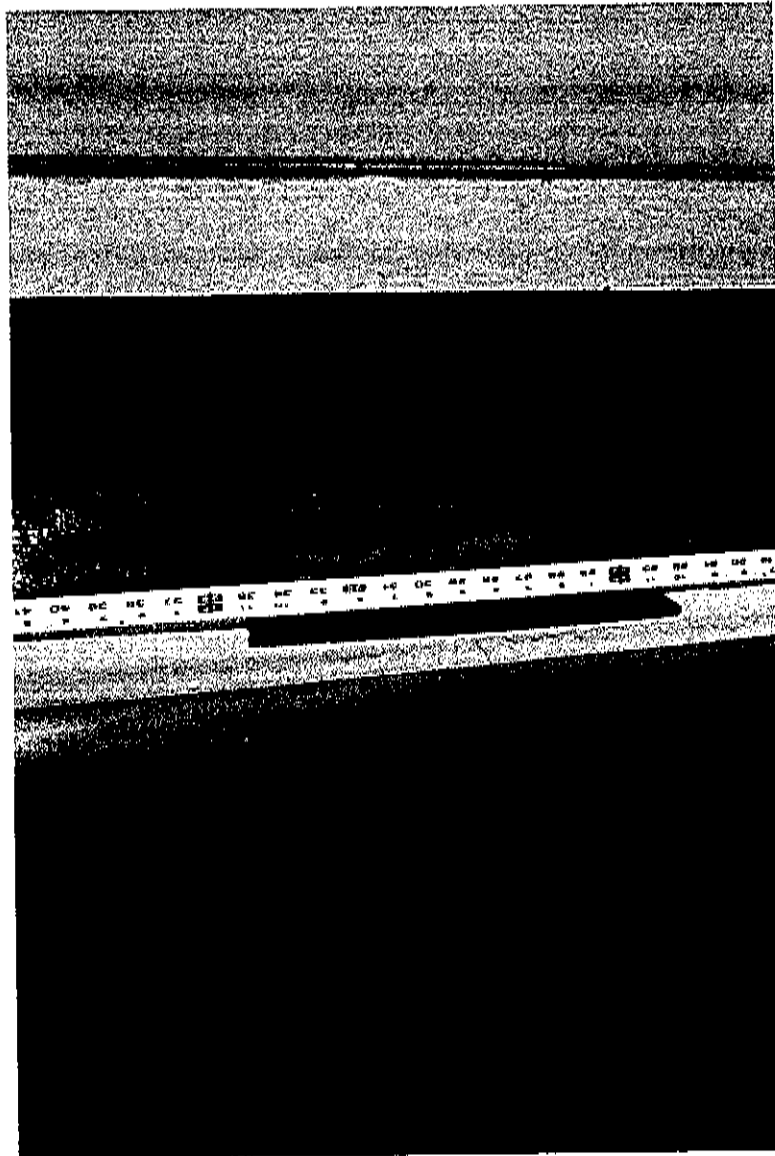
11. Undisturbed butts and joints in the starboard wash rail and side of the house area #1

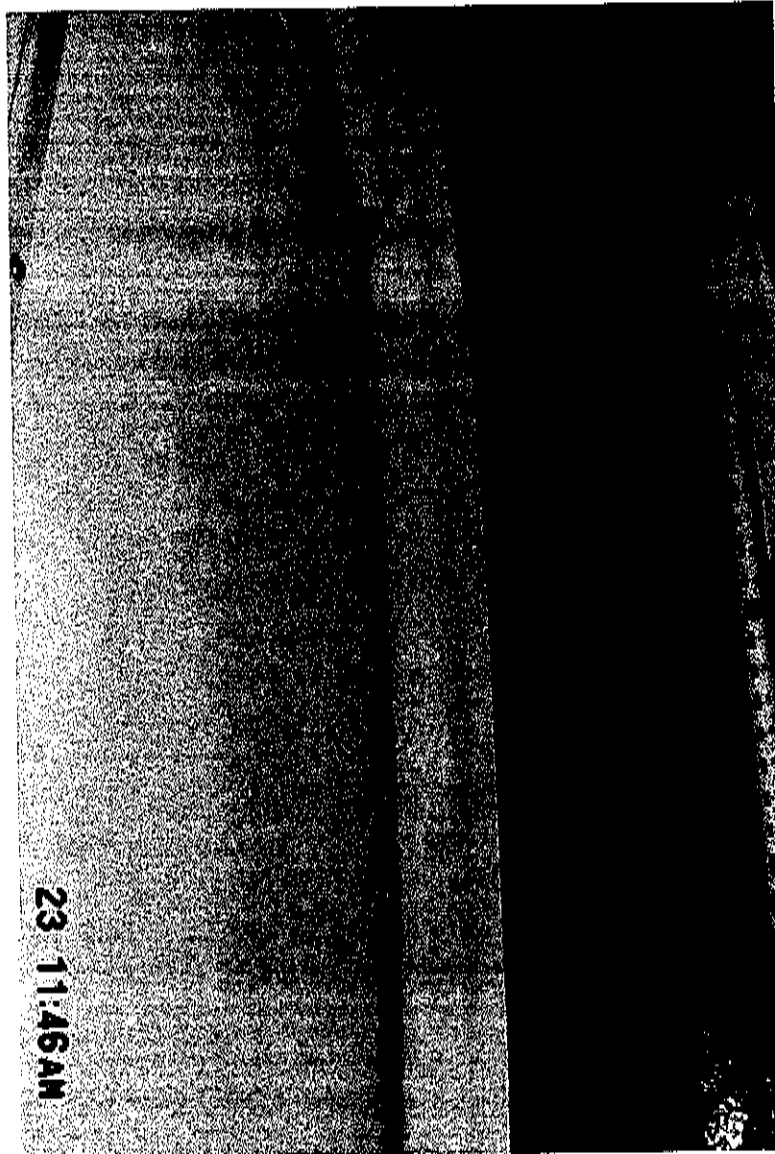
12. Another view of undisturbed butts and joints, starboard side, impact area #1

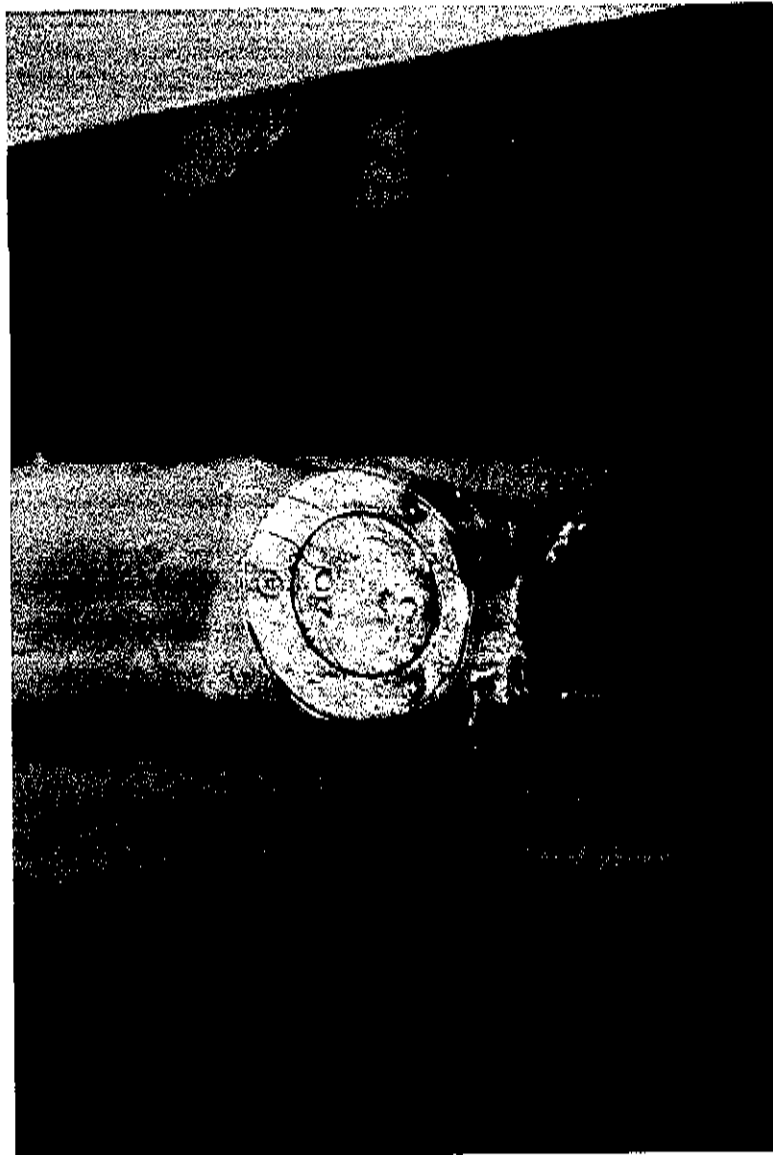
18. Wash rail support knee with integral fuel oil fill area of impact #2.
Note fracture in knee.

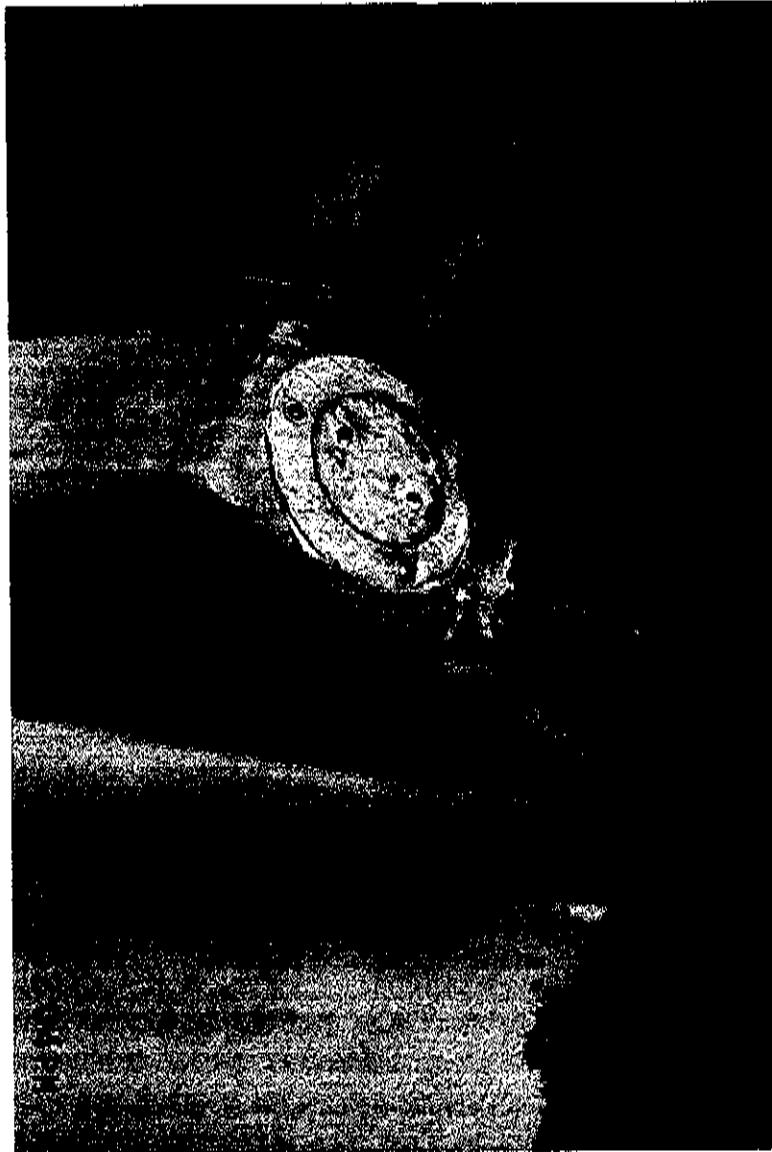
19. Another view of photo #18 subject.
